Catch of the week

Frozen Cooling System Valve Found on a Hydro Power Turbine

Availability & Performance Center | April 2012

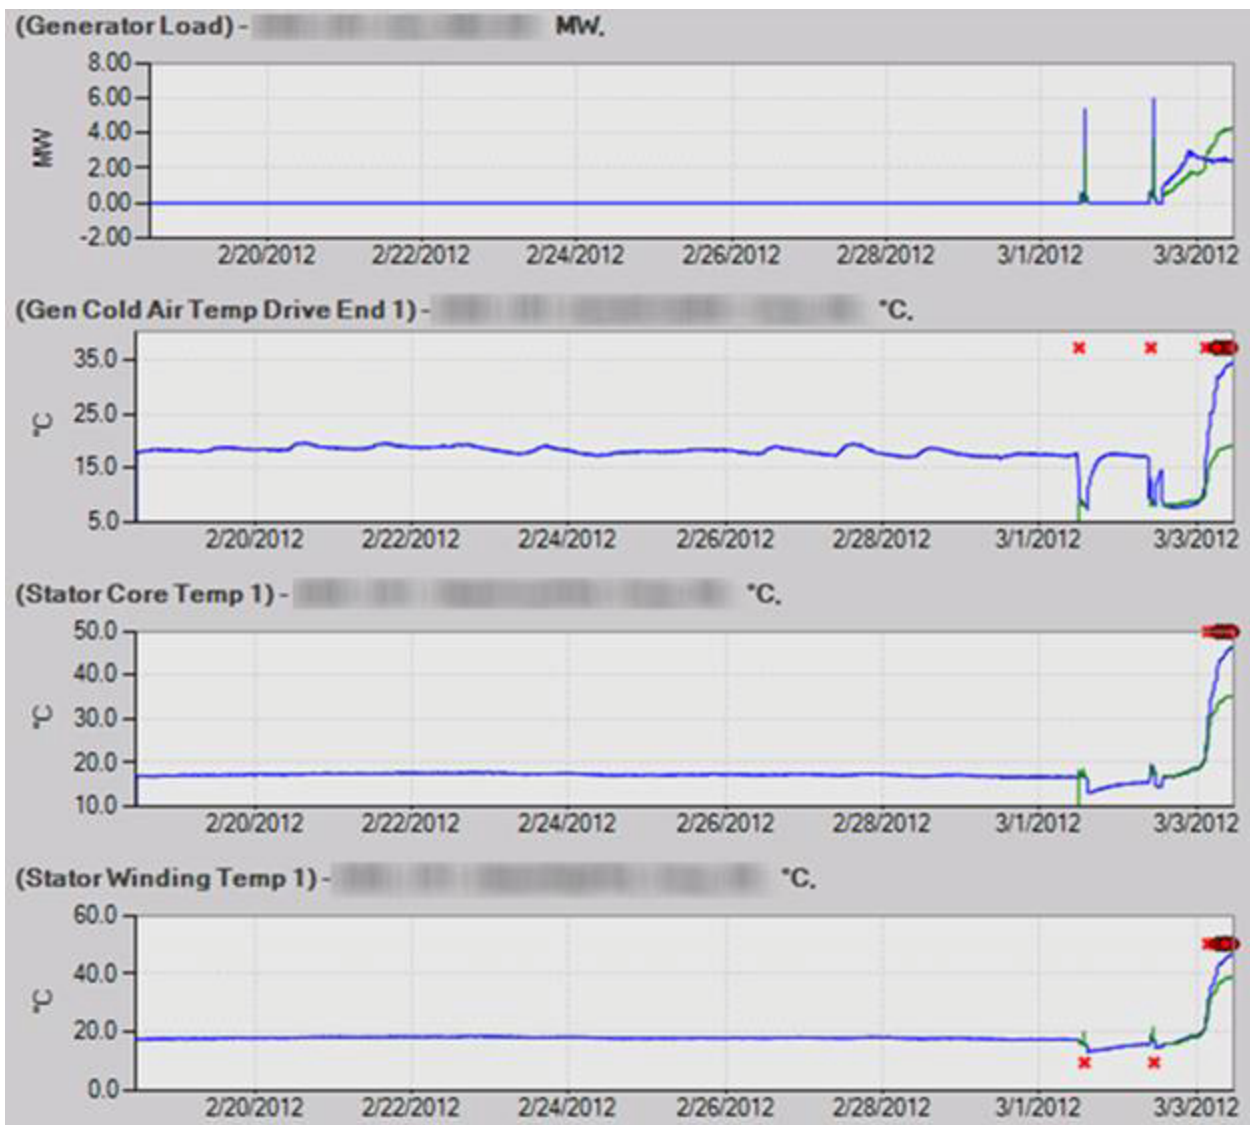
On Saturday, March 3rd, the Proficy SmartSignal solution identified a potential issue with the cooling system for a hydro power turbine. Values for the cooling air temperature were expected to be around 20 degrees Celsius. Actual cooling air temperatures were seen as high as 35 degrees Celsius. At the same time, generator stator winding temperatures were expected to be around 35 degrees Celsius and were seen reaching 50 degrees Celsius. The Availability & Performance Center immediately sent a high priority notification to the client.

Screenshot increases in actual stator and cooling air temperatures (blue) versus expected values (green).

After investigation, the operators reported that this unit was experiencing frazil ice in the cooling system. The operators reported that there was a small 3" manual control valve that they believed became plugged with ice, choking off cooling flow to the hydro turbine.

The client was very appreciative of the indication of the issue. This plant had an actual value alarm on low cooling water flow. However, this alarm was grouped with a set of additional alarms that were known to be false due to an instrumentation issue. The instrumentation issue and existing false alarms masked a new emerging condition. The Availability & Performance Center was able to help the client understand the issue and get the plant back on line. The Availability & Performance Center was also to provide verification that the maintenance action corrected the issue by verifying that stator and cooling temperatures returned to expected values, with subsequent reports.
